Invited Lecture Series: Experimental and Computational Fracture Mechanics of Composites
Department of Mechanical Engineering, University of Utah, March 12, 2015

Fracture of Composites: A Soon-To-Be Old Guy's Perspective

James Ratcliffe

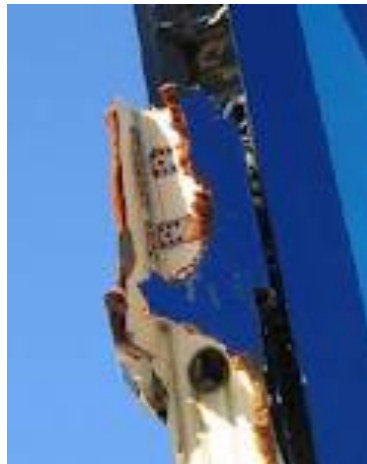
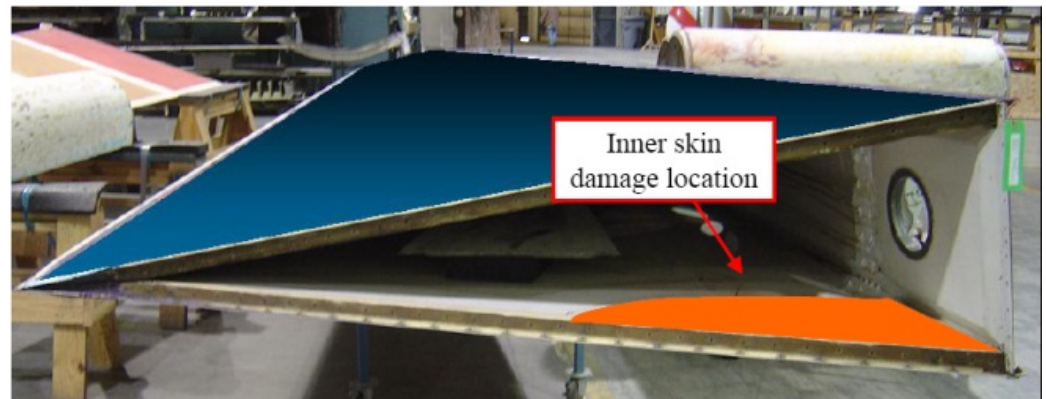
1. Rudder Failure

Pressure difference between inside and outside of honeycomb sandwich structures caused by alternating ambient pressure is a major cause of face sheet peeling loads

Initial disbonds between face sheets and core increase the peeling effect and can decrease the structural reliability significantly

Air-Transit flight 961 (Airbus A310-300):

- Rudder failure due to face sheet disbonding caused by pressure difference and initial disbond

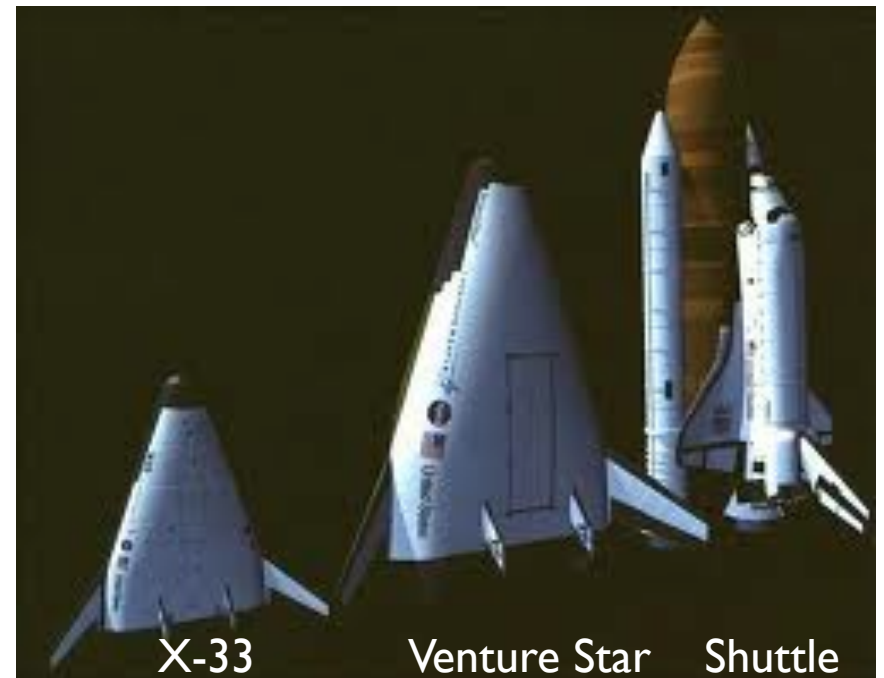
2. X33 Tank Failure

LOX tank (sandwich structure) failed due to cryo pumping

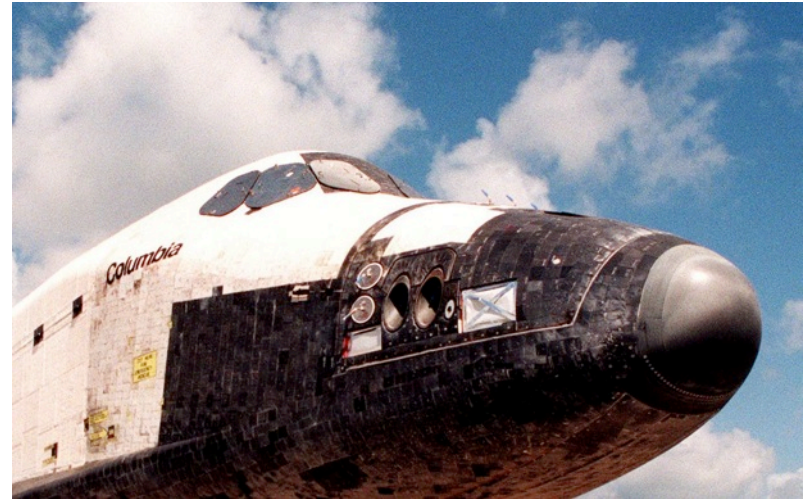
ORBITER WING LEADING EDGE (WLE) DAMAGE TOLERANCE ASSESSMENT

On February 3, 2003, Space Shuttle Columbia crashed killing its seven member crew. Insulating foam was separated from the external tank , which caused damage that resulted in the loss of the Orbiter.

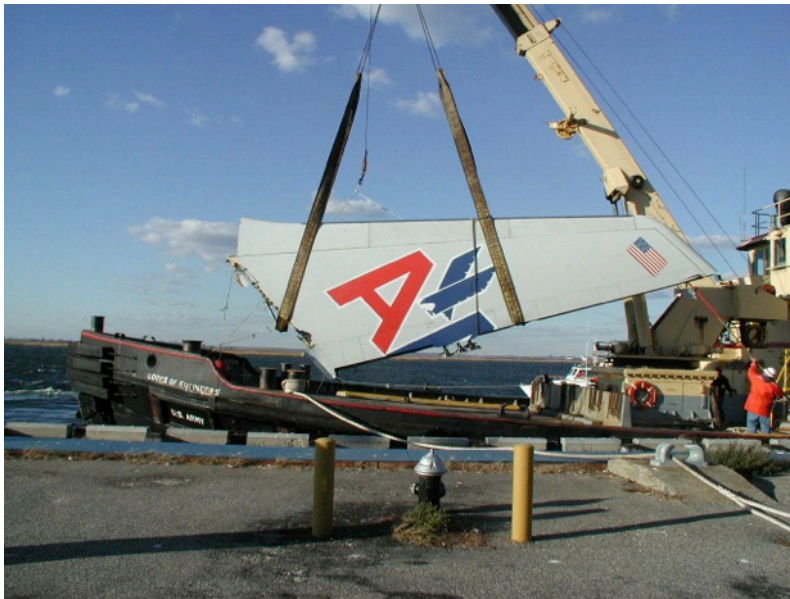
On November 12, 2001, American Airlines Flight 587 crashed shortly after takeoff, killing 260 people on board and 5 on the ground

The probable cause of this accident was the in-flight separation of the vertical stabilizer as a result of the loads beyond ultimate design

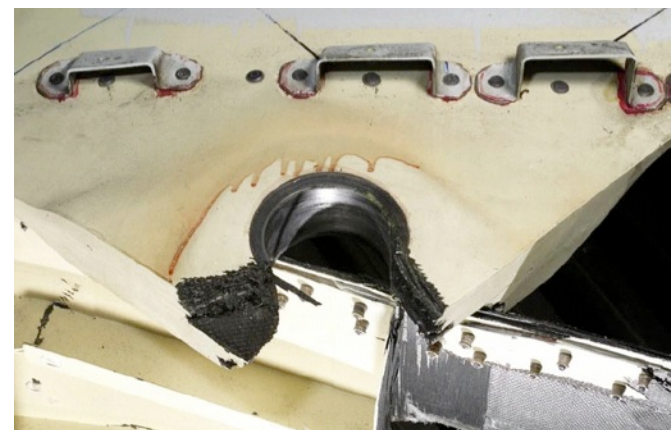
Recovery of Vertical Tail

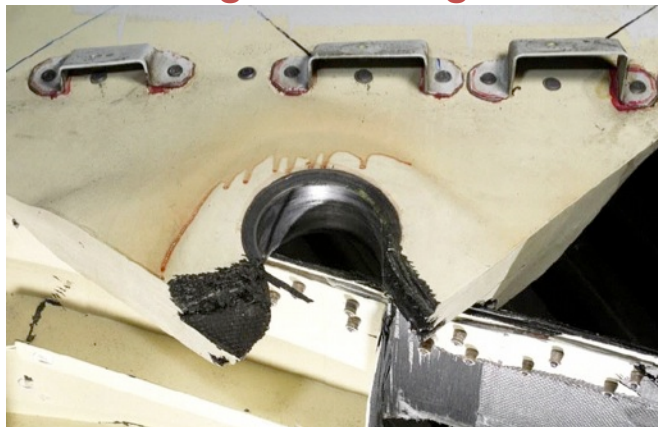
Right Rear Lug

- * Complex 200 ply laminate
- * Numerous plies in form of tape and fabric
- * Numerous curvilinear ply drops

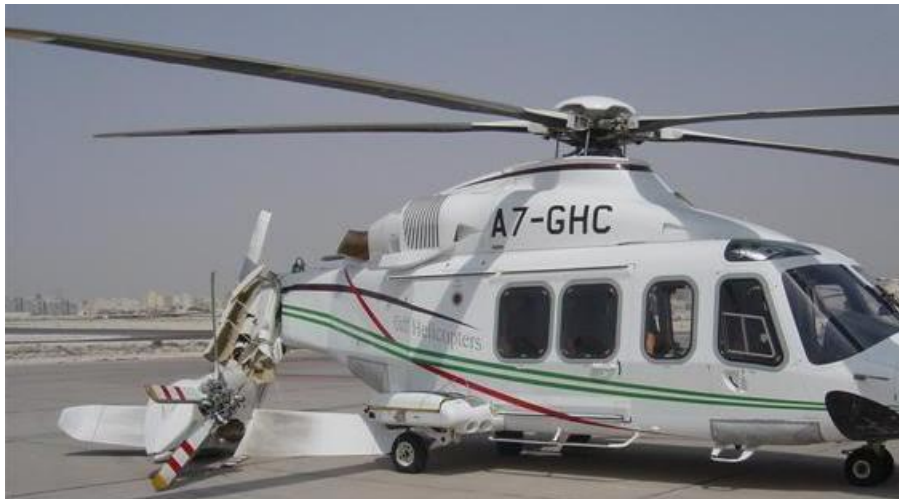
On 25th August, 2009 a Gulf Helicopter AW139 experienced a tail boom failure during a pre-flight taxi manouver

“The most probable root cause of this accident was determined in a tail boom strength degradation caused by **hidden Nomex internal damages** of the RH panel corners areas induced by the previous tail strike event....” Aircraft Accident Investigation Final Report

AW139 with failed tail boom

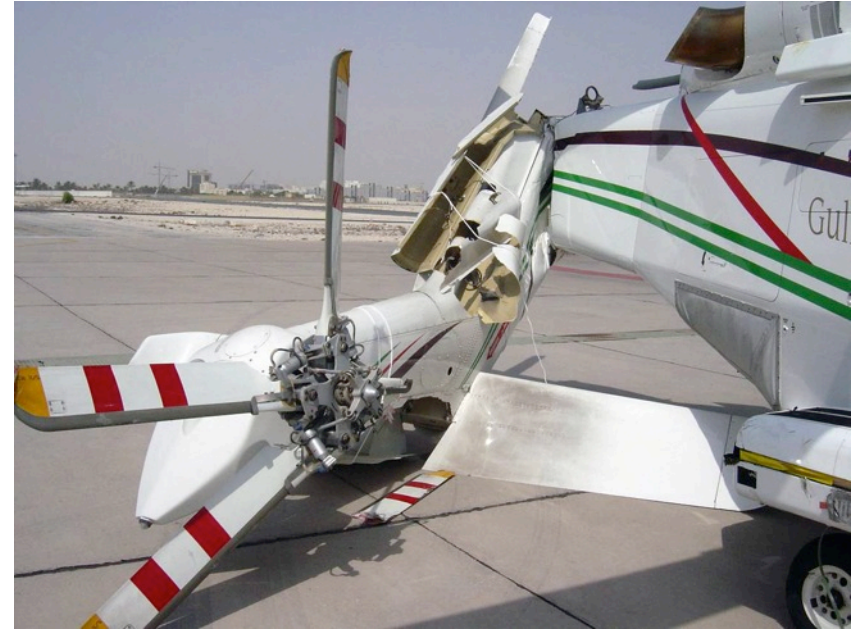
Close-up view of tail rotor

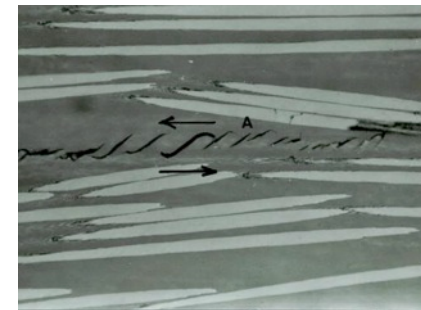
Mode III: Loading along crack plane and parallel to crack front
